# **Investigation of Failure in Main Fuel Pump of an Aeroengine**

M. Sujata, M. Madan, S.K. Bhaumik

Council of Scientific and Industrial Research (CSIR), National Aerospace Laboratories,  
Materials Science Division Bangalore 560 017

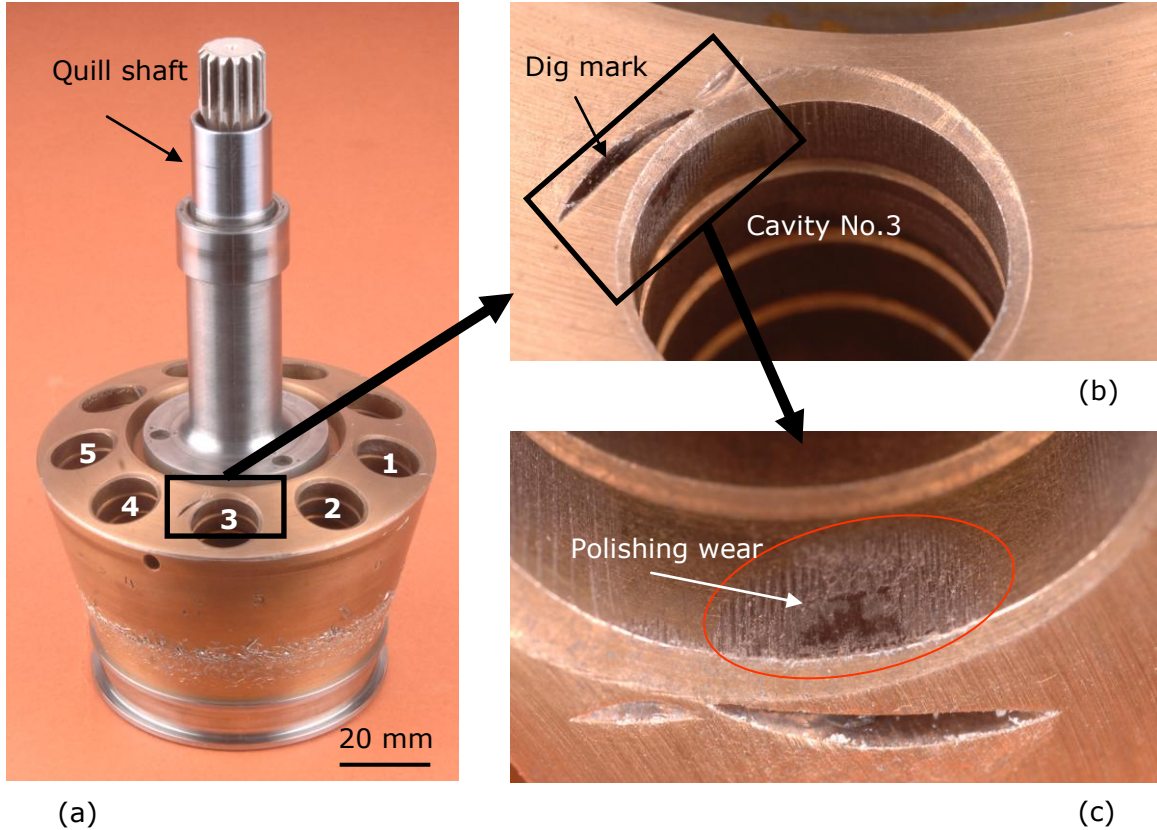
The rotor of the MFP is shown in Fig.2(a). Damages were observed on the outer conical surface of the rotor encompassing a circular band, and located close to the bottom. A dig mark resembling an arc was observed on the face of the rotor in the vicinity of cavity No.3 (Fig.2(b)). Also, can be seen is the polishing wear on a sector of the inner surface of the cavity No.3 (Fig.2(c)). This indicated that the body of the plunger No.3 was preferentially in contact with this region of the cavity surface at least for a part of its operation.

**Figure 2:** (a) Rotor of the MFP; cavity No. indicated, (b) dig mark resembling an arc on the surface facing the swash plate, and (c) polishing wear on the inner surface of the cavity No.3

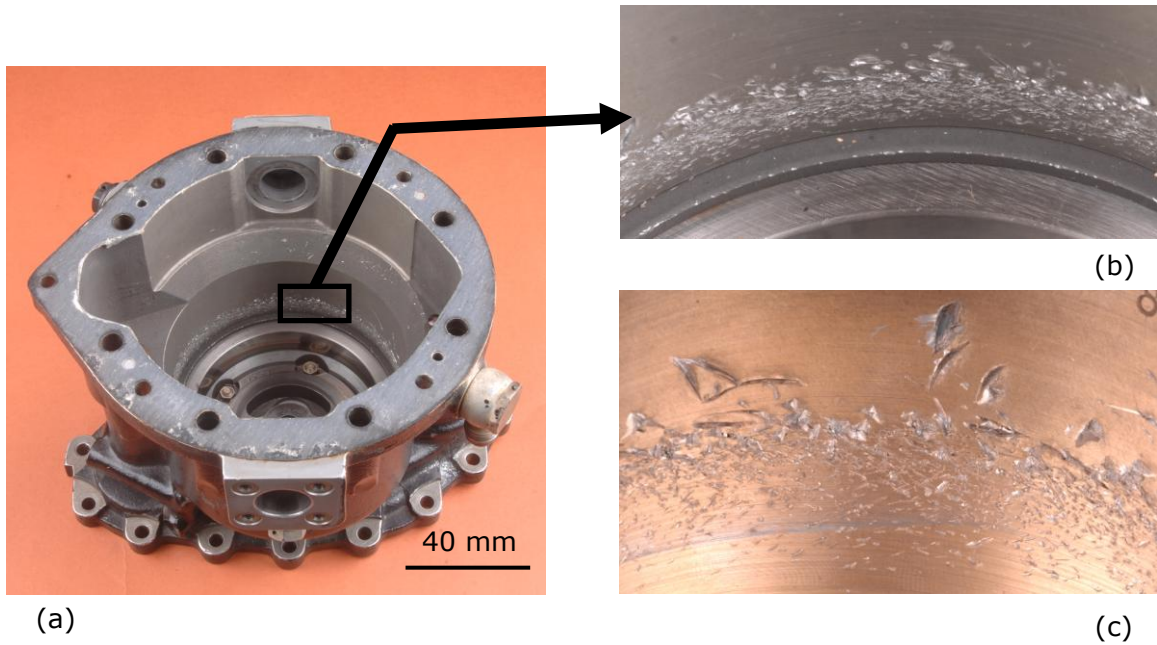
Figure 3(a) shows the body casing of the MFP. It was found to be in tact except for the damages on the inner surface over a circumferential band (Fig.3(b)). Similar damages were observed on the corresponding location on the conical surface of the rotor (Fig.2(a) and Fig.3(c)). It can be seen that the damages were caused due to churning of hard debris during rotation of the rotor. Numerous dig marks, resembling the shape of arcs, indicated that at least one fragment in the debris was sufficiently large. The fragment was part of a curved surface with circular cross section and it appeared to be the fractured part of the plunger No.3, which was recovered from the body casing of the MFP during dis-assembly.

**Figure 3:** (a) Body casing of MFP, (b) damages on the inner surface of the casing, and (c) damages on the outer conical surface of the rotor in the corresponding region

surface had then propagated by fatigue following roughly a circular path leading to dislodgement of material from a sector of the side wall of the plunger. Following this, the dislodged fragment had fallen in the annular space between the rotor and the pump body casing. The churning of this fragment during operation of the pump had damaged the outer conical surface of the rotor and the inner surface of the pump body casing over a circular band.

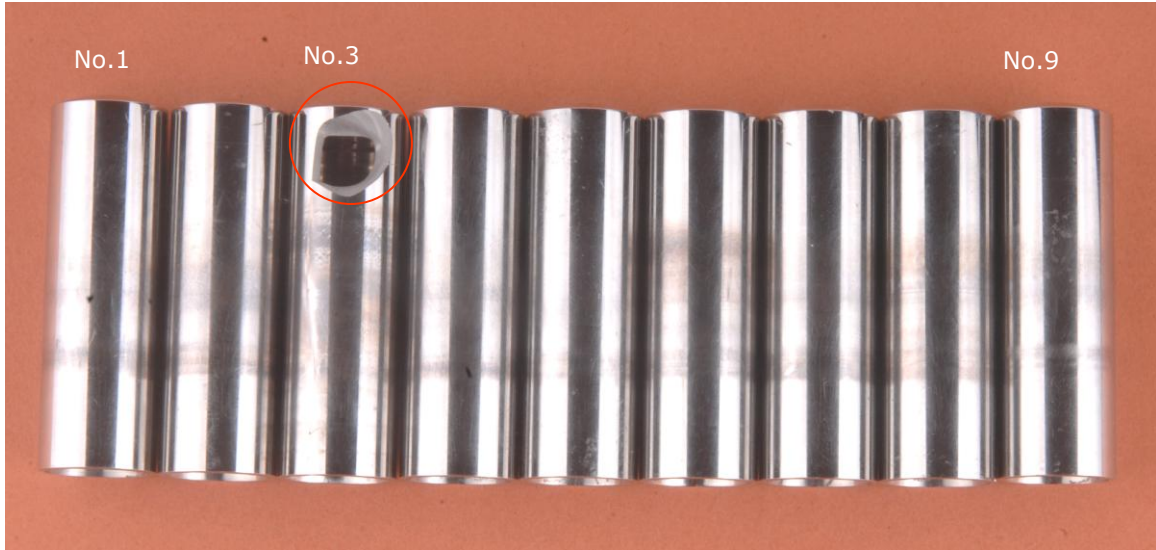
One of the nine plungers of the MFP was found to have a hole on the side wall due to loss of material by fracture (refer Fig.4). This plunger was located in the cavity No.3 of the rotor. A fragment, approximately of circular shape and having a diameter of about 9 mm, got separated from the plunger side wall at a location close to the crown (Fig.5). The fracture surface on this fragment was found damaged and it was smeared with material rich in Cu and Al, picked up from the rotor (made of Cu-alloy) and the body casing (made of Al-alloy).

**Figure 4:** Nine plungers of the main fuel pump and fracture in the side wall of plunger No.3

Fractographic study confirmed that plunger No.3 of MFP has failed in progressive manner leading to dislodgement of a piece of material from the side wall of the plunger close to the crown. The resultant hole in the plunger was responsible for fuel leakage internally in the MFP, which in turn prevented generation of fuel pressure to the required level. As a consequence, there was less fuel delivery to the engine leading to winding down of engine RPM and subsequent accident.

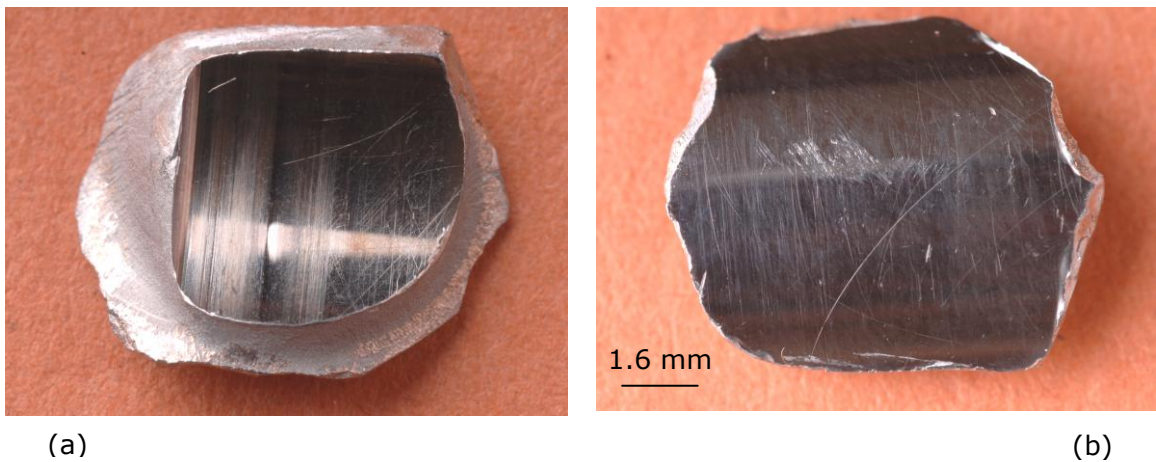
**Figure 5:** Fractured and dislodged part of MFP plunger No.3: (a) inner surface, and (b) outer surface

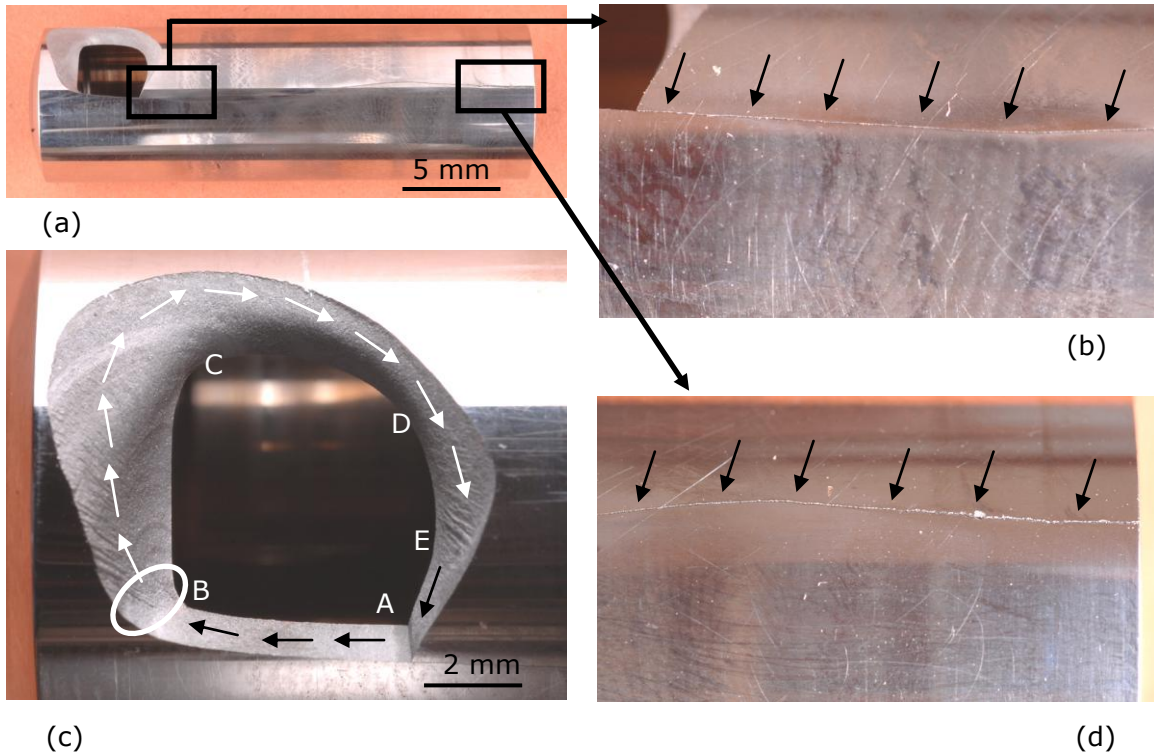
Examination of the plunger No.3 showed presence of beach marks or crack arrest marks on the fracture surface, indicative of progressive mode of crack propagation (Fig.6). From the orientation of the beach marks, the fatigue crack initiation site was identified at the region marked 'B' in Fig.6(c). After initiation, the fatigue crack had propagated progressively over the region BCDE before giving way to final overload fracture (region EA in Fig.6(c)) resulting in dislodgement of a fragment from the plunger side wall. The gross fractographic features in the region AB indicated that this surface was created by fast fracture. Examination also revealed that the fracture surface AB was the extension of a through thickness longitudinal crack that was present over the entire length of the plunger (Fig.6(b,d)).

**Figure 6:** (a) Plunger No.3, (b) crack along the longitudinal direction (black arrows), (c) fracture surface showing fatigue crack origin, encircled (B), progressive crack propagation direction over region BCDE (white arrows) and overload fracture in regions EA and AB (black arrows), and (d) extension of the crack shown in (b) up to the bottom edge of the plunger

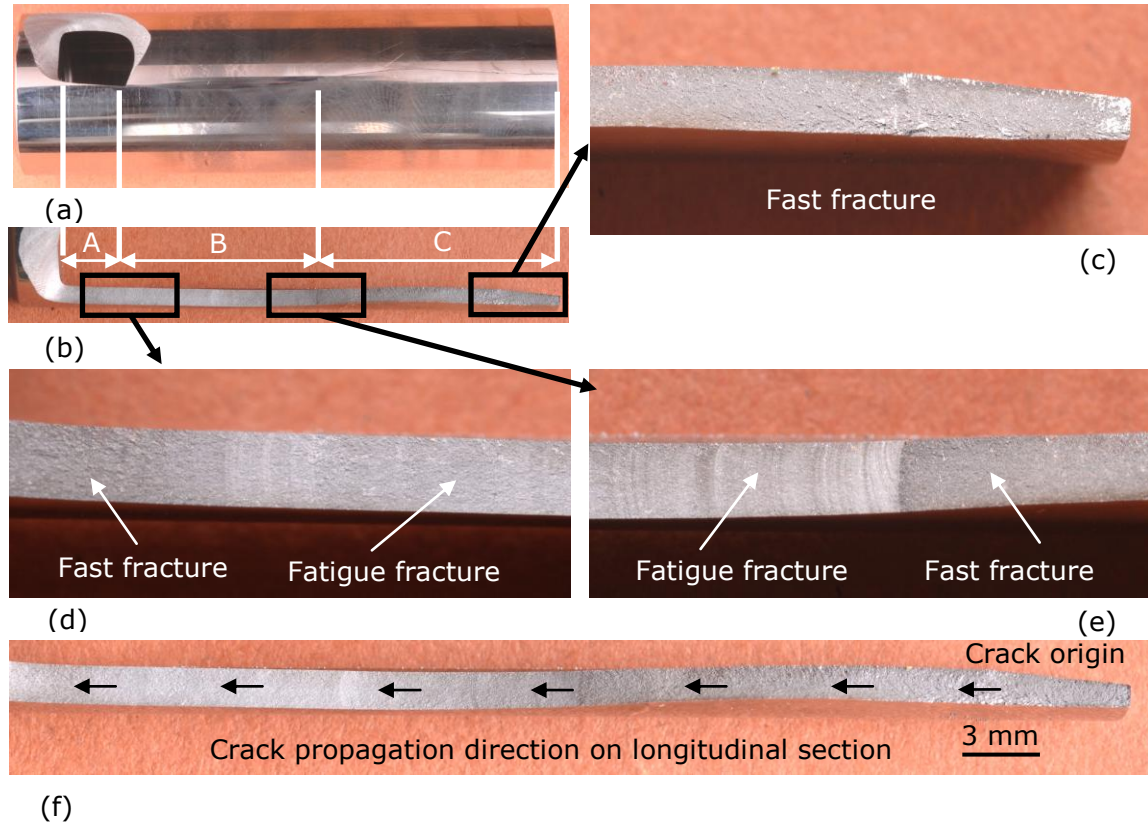
Suitable cut was provided in the plunger and the longitudinal crack surface was opened for further study (Fig.7). Examination revealed that the longitudinal crack on the plunger had three distinct zones, two fast fracture regions separated by a region of fatigue fracture (Fig.7(b)). Based on the orientation of the crack arrest marks, the crack initiation region and the crack propagation direction were identified, and these are shown in Fig.7(f).

**Figure 7:** (a-b) Three distinct fracture regions along the longitudinal crack on plunger No.3, (c) fast fracture in region C, (d) transition of fatigue to fast mode of crack propagation from region B to A, (e) transition from fast fracture to fatigue mode of crack propagation from region C to B, and (f) crack initiation and propagation along the longitudinal direction

It has been established through fractographic study that the fatigue failure in plunger No.3 was promoted due to generation of an overload crack in the longitudinal direction over a length of about 22 mm from the bottom edge. Such longitudinal cracking of the plunger due to hoop-stress is unlikely under the operating fuel pressure. It, therefore, appears that there was abnormal loading on the edge of the plunger through the spring and the guide located inside.

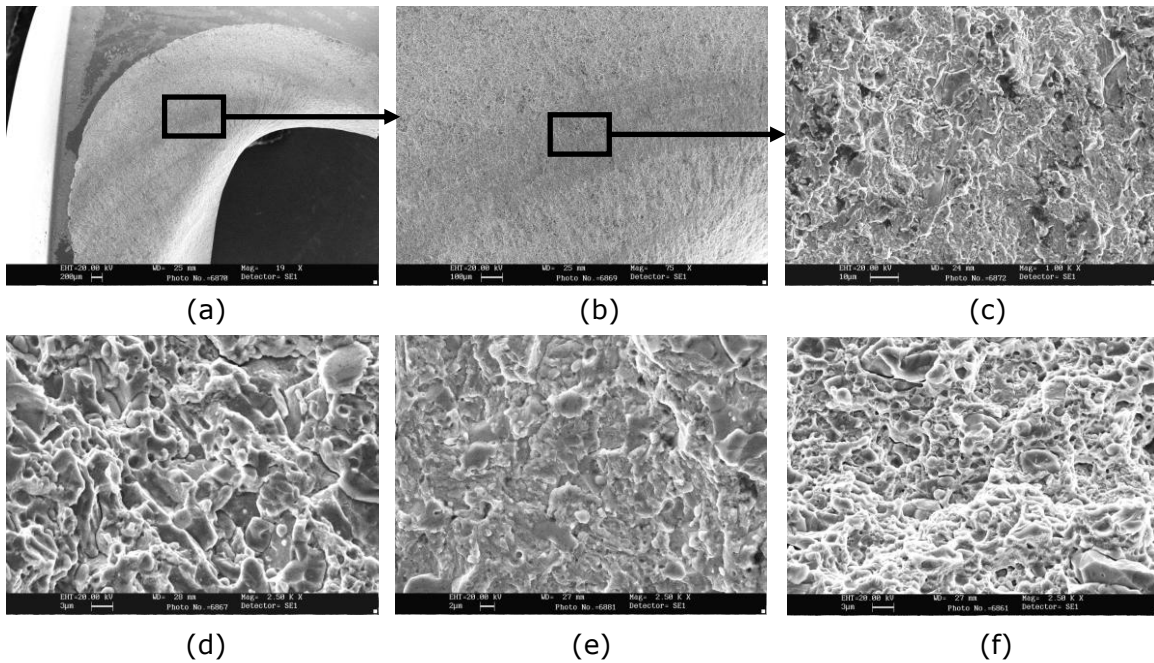
The modes of crack propagation at different regions on the plunger were confirmed through scanning electron fractographic study. Fatigue striations and dimples were seen on the progressive crack propagation zones and fast fracture regions, respectively (Fig.8).

**Figure 8:** Scanning electron fractographs: (a-c) fatigue mode of crack propagation in region BCDE marked in Fig. 6(c), and (d) fast fracture, (e) fatigue fracture, and (f) fast fracture in regions A, B and C respectively marked in Fig. 7(b)

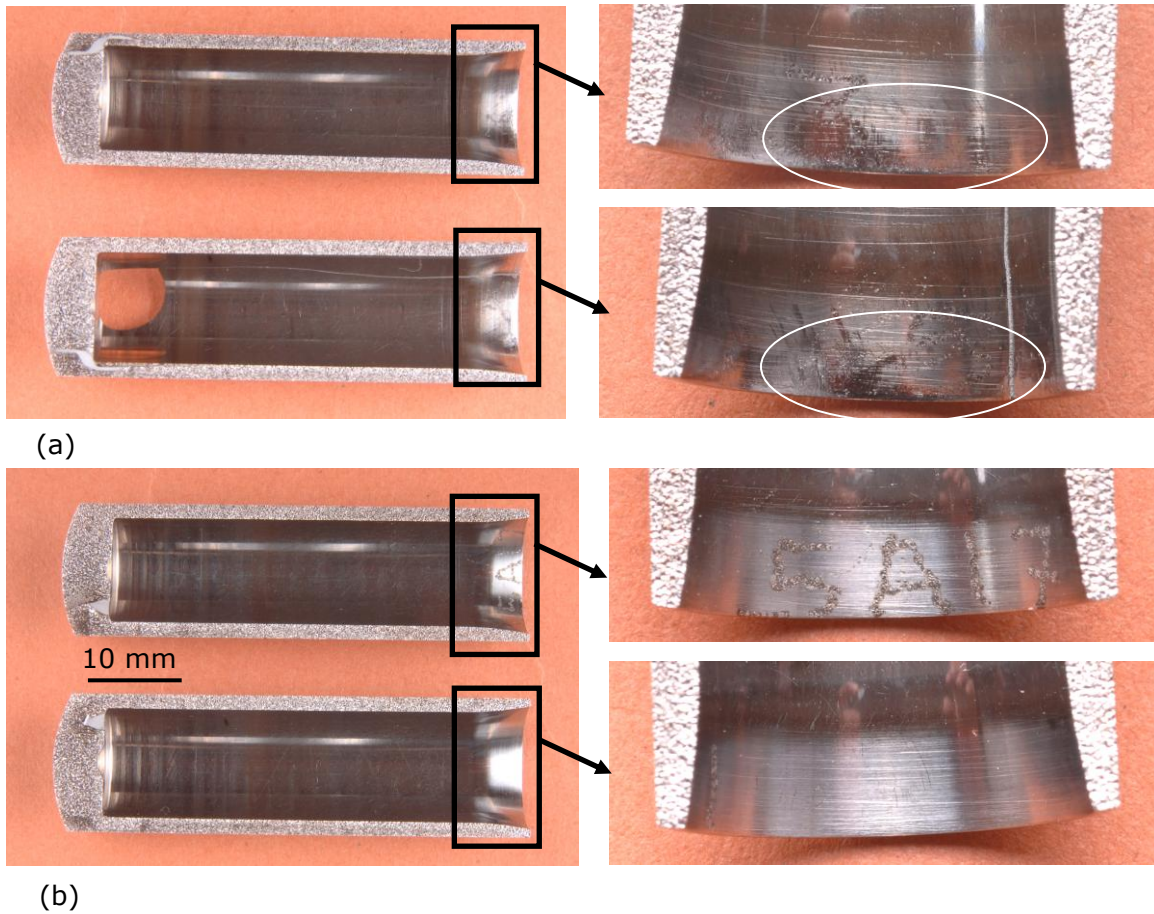
Fractographic study suggested that there was generation of an overload crack at the bottom edge of the plunger, which subsequently propagated by fatigue mechanism. Examination of this region showed impact damages on the tapered inner surface (Fig.9(a)). These damages were observed only on the plunger No.3 and the other eight plungers were found free from any such damages (Fig.9(b)).

**Figure 9:** Inner surface of (a) plunger No.3, and (b) plunger No.1; damages on the taper surface of plunger No.3 encircled

Examination of the inner surface of the plunger at the overload crack origin region showed distress in the form of rubbing with the spring. The rubbing took place in regions where the inner surface of the plunger surface is tapered outward. The rubbing marks were found to be unique to plunger No.3 and the other plungers were found to be free from such damages. It is to be noted that the spring of the plunger No.3 had broken into four pieces. Therefore, the contact of the spring with the tapered surface of the plunger was possible because of this breakage.

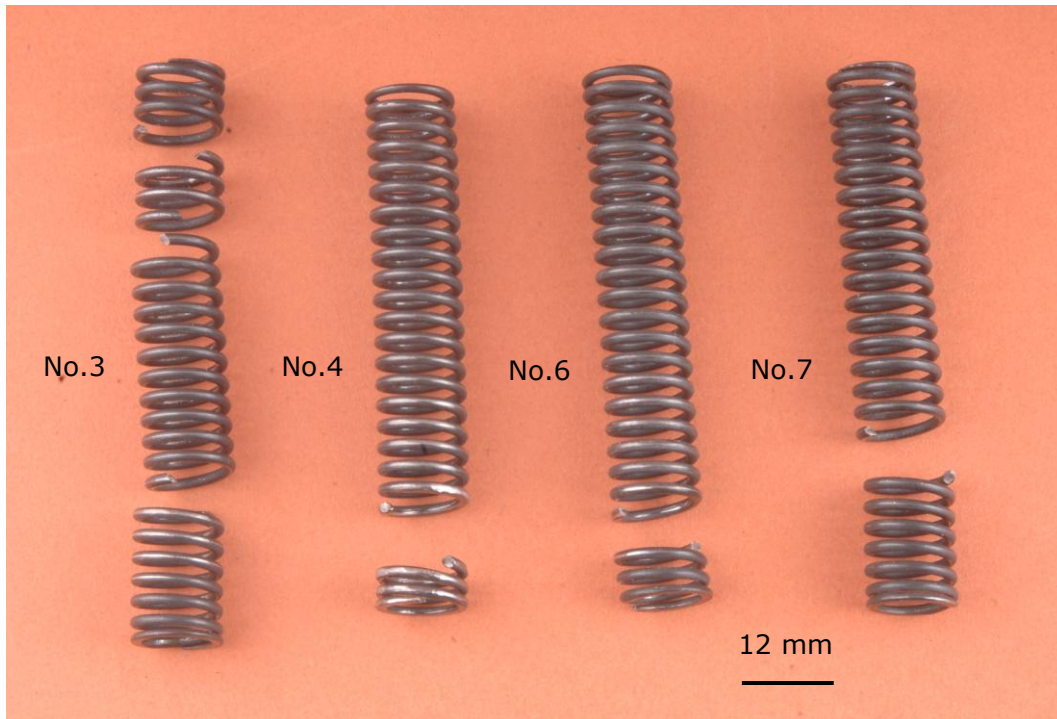
The springs of the plunger Nos. 3, 4, 6 and 7 were found fractured. Spring No. 3 had fractured into four pieces, while the other three springs had fractured into two pieces each (Fig.11).

**Figure 11:** Fractured springs of the MFP; the locations of the springs in the corresponding plungers indicated

- (a) It is recommended that the springs of the production batch in question be rejected. Also, MFPs which have been assembled using springs from this batch be withdrawn from service and the springs be replaced.
- (c) The surface condition of the available raw material must be evaluated. In case corrosion pits are observed, the wires must be rejected.
- (b) Appropriate procedure should be followed for surface protection of the raw material wire as well as the manufactured springs that are kept in the bonded stores.

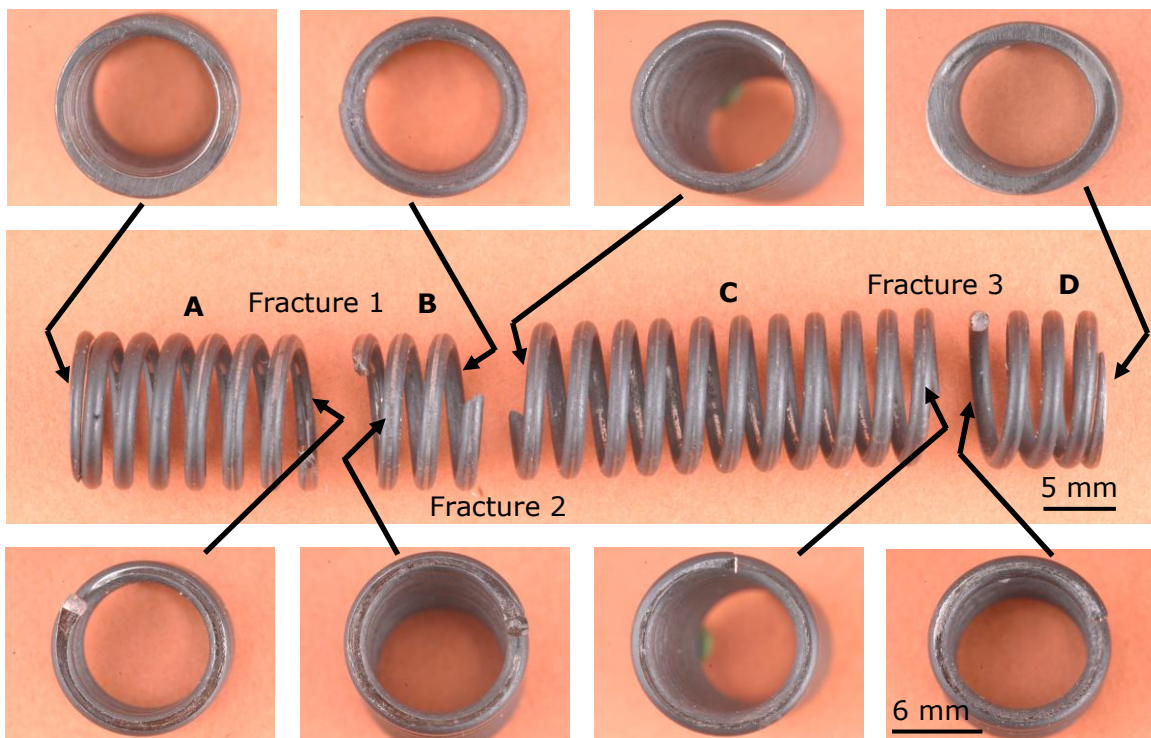
The four fractured parts of the spring No. 3 are shown in Fig.12. The fractured part B was found entangled in the fractured part C. Examination of the faces of each of the fractured parts of the spring showed that the faces corresponding to fracture 1 had deformed/flattened to a large extent. The damages on the faces of the other fractured parts were found to be relatively less. This indicates that fracture 1 was the first in the sequence of occurrence, followed by which the other two fractures had occurred.

The spring ends corresponding to the fracture 1 were found damaged/rubbed substantially resulting in complete obliteration of the fractographic features. The other fracture ends of the spring were found relatively preserved. These fractures were found to be oriented approximately at  $45^{\circ}$  with the wire axis of the spring. Examination revealed that the fracture surfaces were flat and smooth in appearance, indicative of progressive mode of crack propagation.

**Figure 12:** Fractures in spring No.3 showing relative damages on the faces of the broken parts

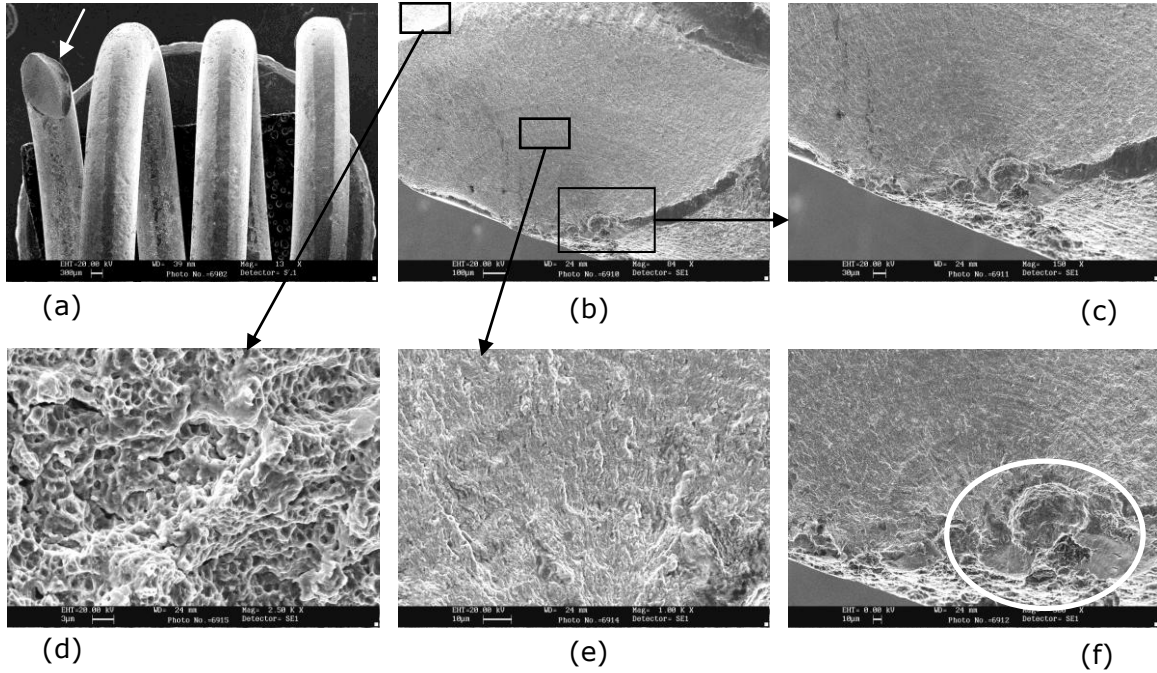
Figures 13 and 14 show the scanning electron fractographs of the broken ends corresponding to the fractures 2 and 3 respectively. The fracture surfaces showed clearly delineated half-moon shaped region consisting of beach marks or crack arrest marks, typical of fatigue mode of crack propagation. From the orientation of the beach marks, the fatigue crack origins were identified and they were found to be corrosion pits on the spring surface. Further examination showed presence of numerous corrosion pits on the surface of the spring (Fig.15). Compositional analysis showed that corrosion products in these pits contained corrosion species such as chlorine (Table 2).

**Figure 13:** Scanning electron fractographs of one of the mating surfaces of fracture 2 of spring No.3: (a) fracture surface oriented approximately  $45^{\circ}$  with the wire axis (arrow), (b) crack arrest marks or beach marks, (c) fatigue crack origin region, (d) dimple rupture, (e) fatigue striations, and (f) corrosion pits at the fatigue crack origin (encircled)

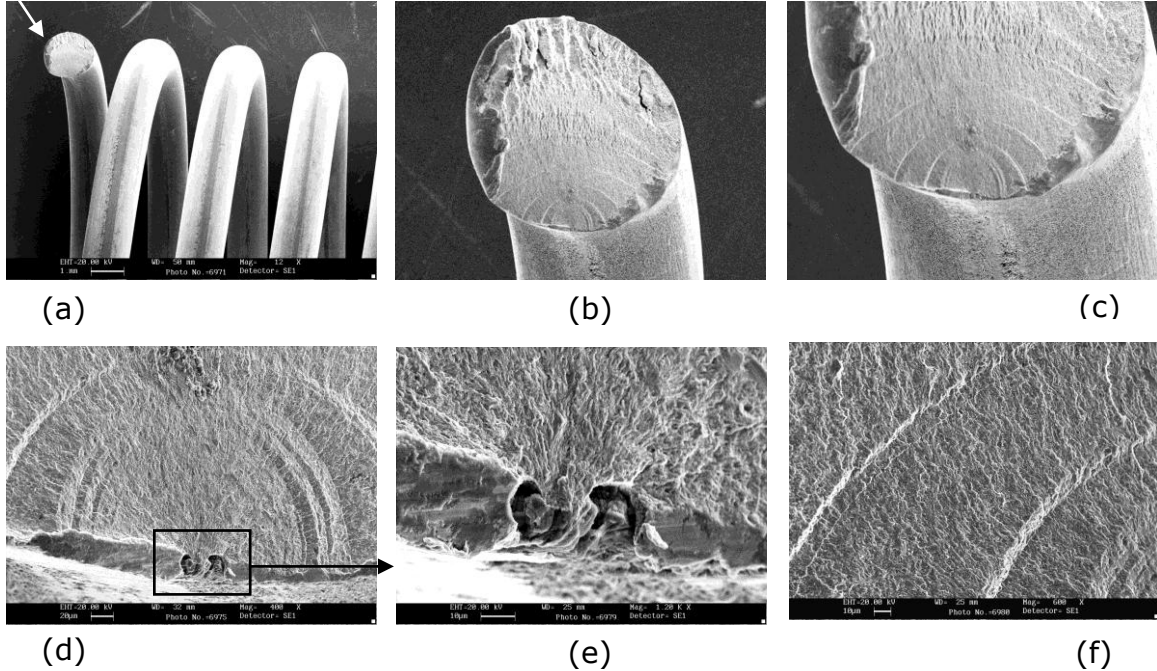
**Figure 14:** Scanning electron fractographs of one of the mating surfaces of fracture 3 of spring No.3: (a) fracture surface oriented approximately  $45^{\circ}$  with the wire axis (arrow), (b) crack arrest marks or beach marks, (c) magnified view showing concentric crack arrest marks, (d) fatigue crack origin (rectangular box), (e) corrosion pits at the fatigue crack origin, and (f) fatigue striations

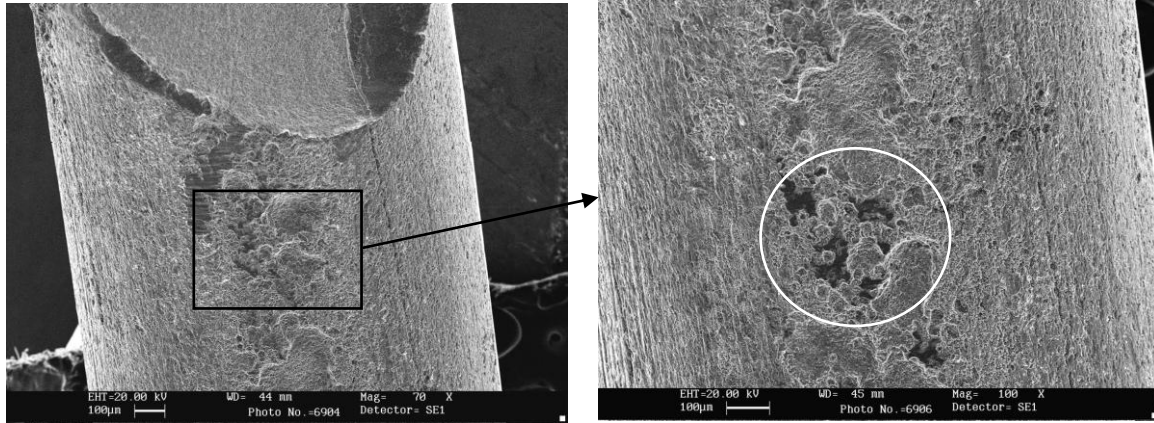
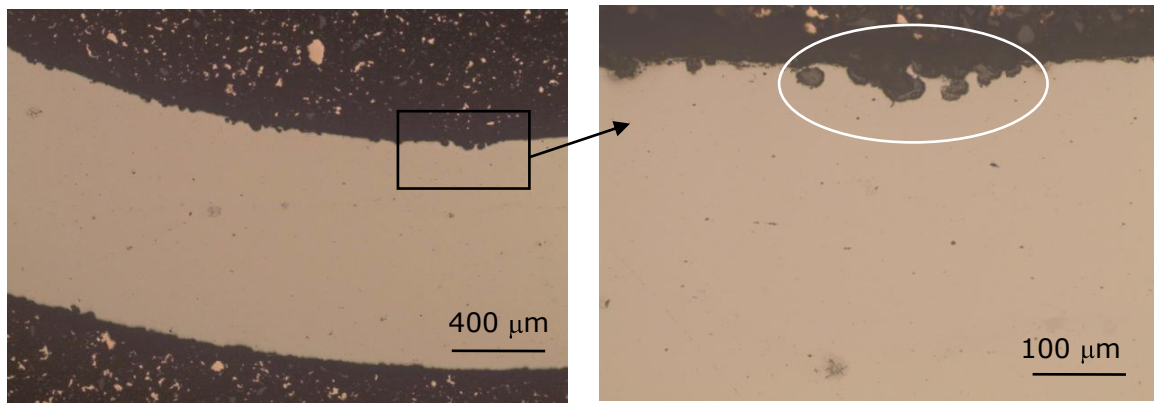
**Figure 15:** (a) Scanning electron images of the surface of the broken spring No.3 showing corrosion pits, and (b) optical micrographs of the longitudinal section of the spring wire showing corrosion on the surface (encircled)

Laboratory investigation showed that all the fractures in spring No.3 were by fatigue mechanism. It was also established that the premature fatigue fracture of the spring was promoted due to corrosion on the spring surface.

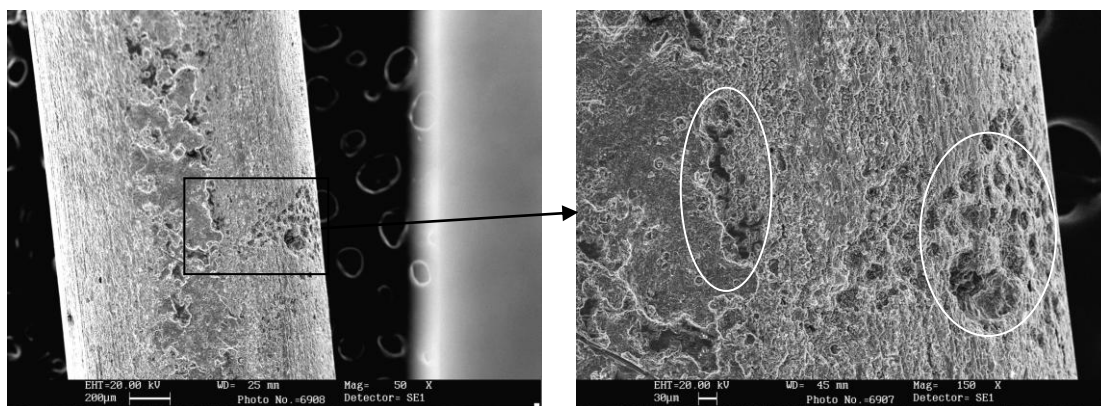
Fractographic study confirmed that the fractures in springs 4, 6 and 7 were also by fatigue mechanism. The crack origin regions in these springs were largely damaged and hence, no further study could be conducted. However, corrosion pits were observed on the surfaces of these springs as well (Fig.16 and Table 2).

**Figure 16:** Scanning electron images of the surface of the broken spring No.6 showing corrosion pits (encircled)

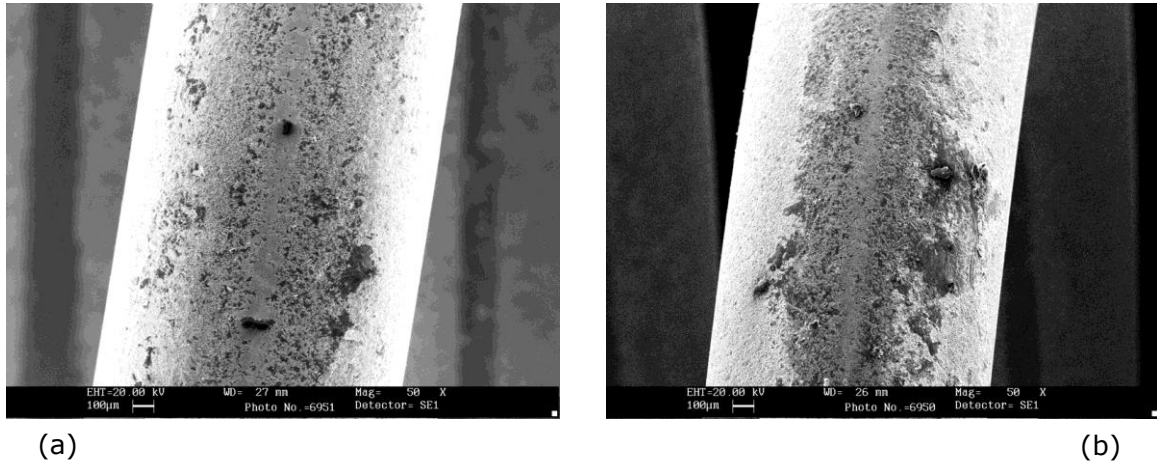
The raw material wire and the unused springs from the same batch of production as the fractured ones were evaluated. Examination revealed corrosion on the surfaces of the raw material as well as the springs (Fig.18). Compositional analysis showed presence of chlorine in the corrosion products (Table 2).

**Figure 18:** Scanning electron images showing corrosion on the surfaces of the (a) raw material wire, and (b) an unused spring

Follow-up investigation revealed corrosion on the surface of the raw material wire that was used for the fabrication of the springs. Same observations were also made on the surface of the springs belonging to the same batch of production. On examination of the records, it was found that the raw material wires were procured at least 12-15 years ago, and they were kept in bonded stores without proper surface protection. The interaction of the virgin material with the atmosphere for a prolonged period was responsible for the development of corrosion pits on the surface of the wires. The same defects got carried forward when the springs were fabricated from these wires. Therefore, the primary reason for the failure was the improper storage of raw material wires used for the fabrication of MFP springs.
